**Flood Control Project Maintenance
Levee Inspections**
LMA District Cover Sheet
Spring 2019 Levee Inspection Results

Reclamation District No. 1000 Natomas

Spring 2019 Levee Inspection Results

Waterway			Bank	Unit Miles
Unit No. 01 Sacramento River			Left	18.28
	Spring (March - May)	Summer (June - August)	(September - November) Fall	Winter (December - February)
Unit Maintenance Rating (Fall Only)				
Date of Inspection	4/16/2019 - 4/16/2019			
DWR Inspector	Sterling York			
Accompanied By	Don Caldwell RD1000

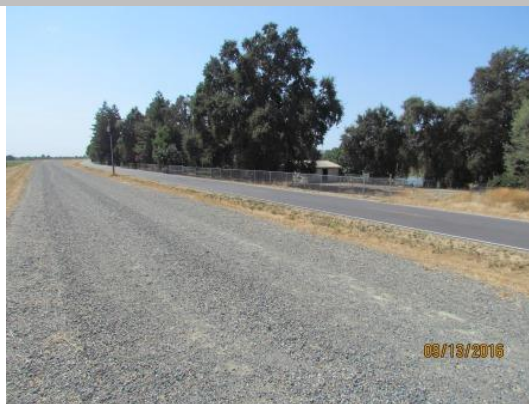
Photo 1 of 1 : SP_2019_RD1000_31_136_20190305_00049.jpg

View of an encroachment, 'Fence'.

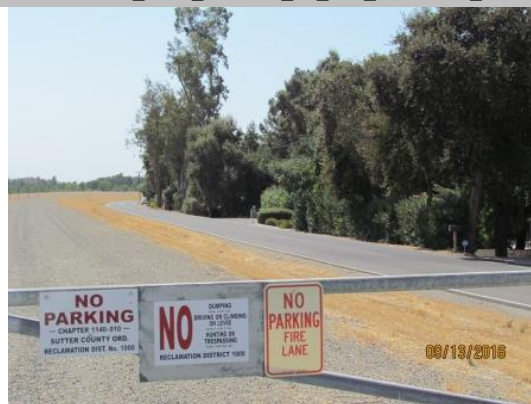
Photo 1 of 1 : SP_2019_RD1000_31_133_20190305_00048.jpg

Typical Garden Hwy 'Landscaping'.

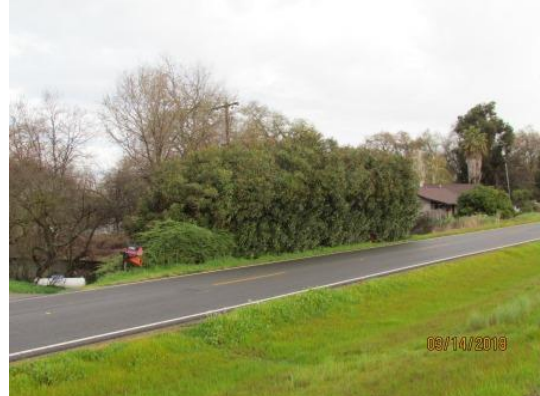
Photo 1 of 1 : SP_2019_RD1000_31_129_20190305_00047.jpg

View looking upstream waterside of landscape vegetation that is blocking access and visibility to the levee.

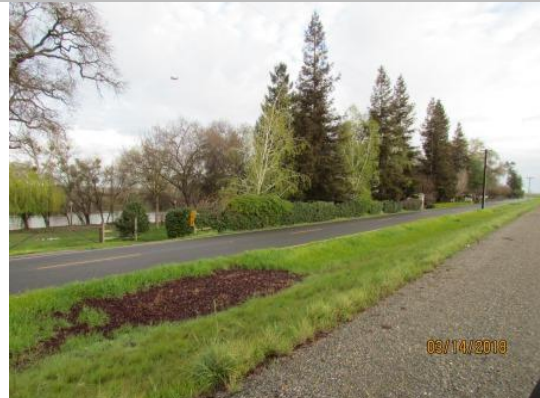
Photo 1 of 1 : SP_2019_RD1000_31_122_20190305_00046.jpg

View looking upstream waterside of landscape vegetation that is blocking access and visibility to the levee.

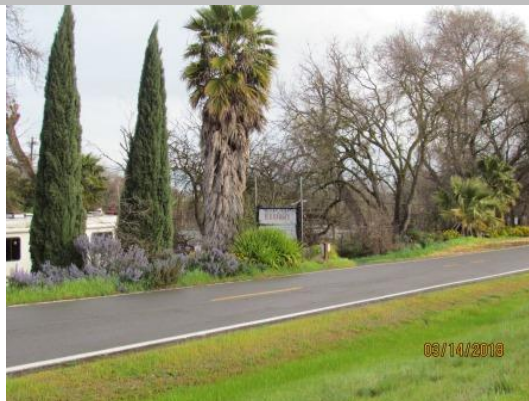
Photo 1 of 1 : SP_2019_RD1000_31_121_20190305_00045.jpg

View looking upstream waterside of landscape vegetation that is blocking access and visibility to the levee.

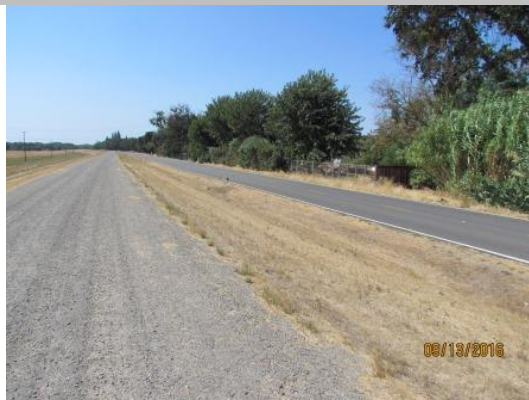
Photo 1 of 1 : SP_2019_RD1000_31_120_20190305_00044.jpg

Typical landscape vegetation along the waterside in front of residences.

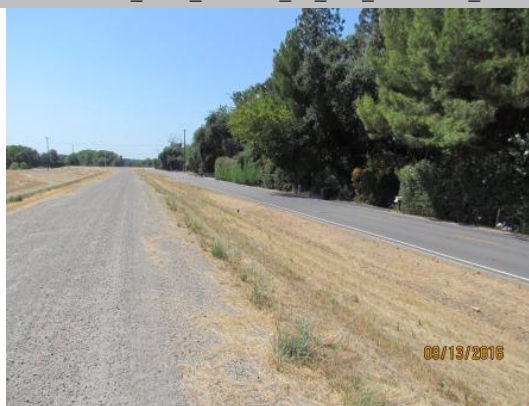
Photo 1 of 1 : SP_2019_RD1000_31_118_20190305_00043.jpg

This photo was taken from the crown facing downstream looking down the waterward levee slope at unacceptable landscaping.

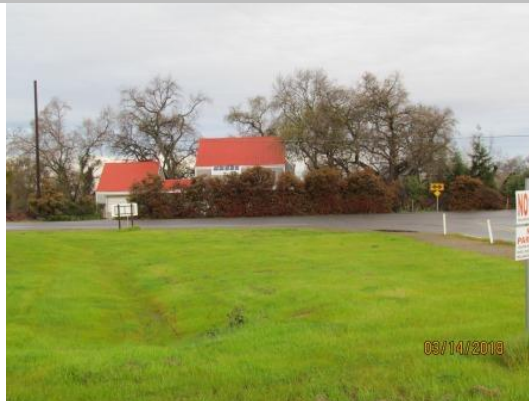
Photo 1 of 1 : SP_2019_RD1000_31_113_20190305_00041.jpg

View looking at waterside landscape vegetation that is blocking access and visibility to the levee.

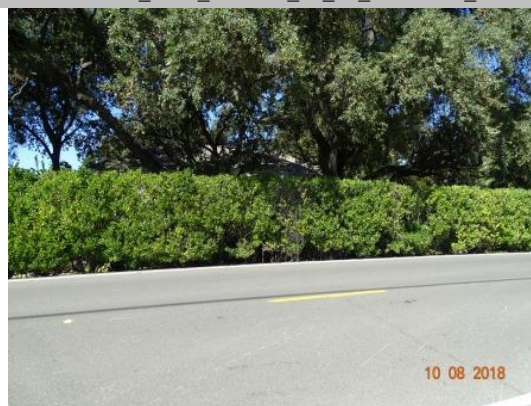
Photo 1 of 1 : SP_2019_RD1000_31_68_20190305_00027.jpg

View at landscape vegetation that is blocking visibility and access, Fall 2018.

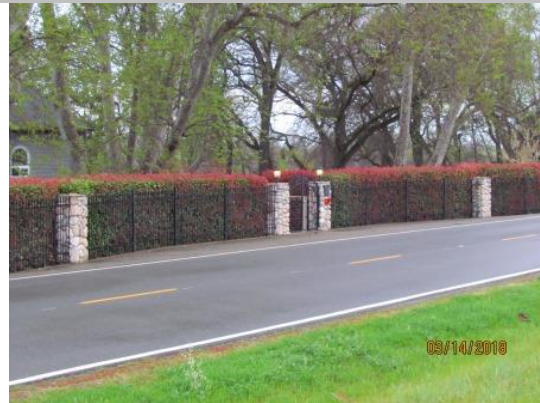
Photo 1 of 1 : SP_2019_RD1000_31_95_20190305_00038.jpg

View looking at waterside landscape vegetation that is blocking access and visibility to the levee.

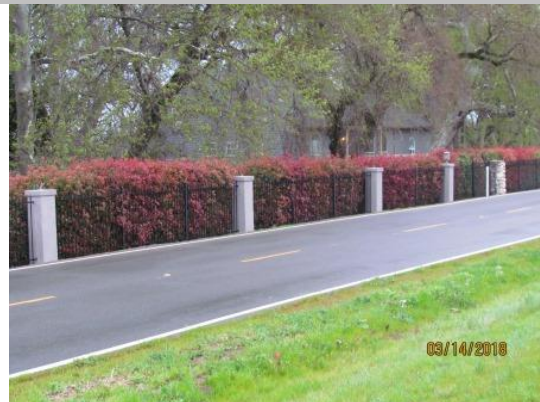
Photo 1 of 1 : SP_2019_RD1000_31_94_20190305_00037.jpg

View looking at waterside landscape vegetation that is blocking access and visibility to the levee.

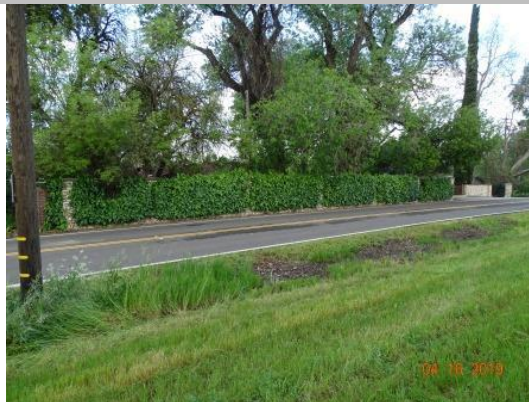
Photo 1 of 1 : SP_2019_RD1000_31_89_20190418_00052.jpg

View of landscape vegetation that is blocking visibility and access.

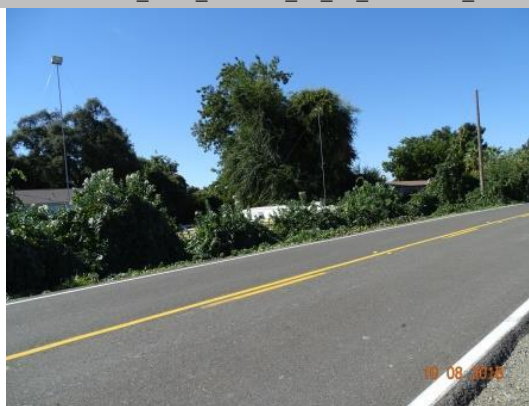
Photo 1 of 1 : SP_2019_RD1000_31_87_20190305_00035.jpg

View of landscape vegetation that is blocking visibility and access.

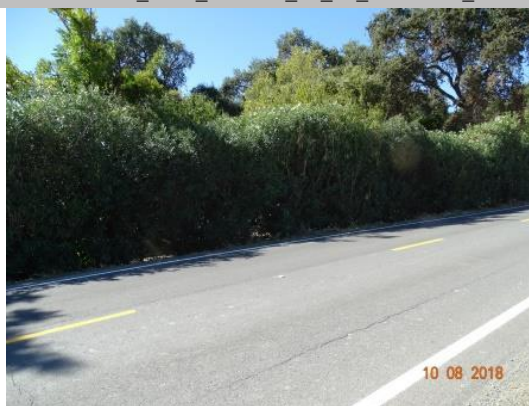
Photo 1 of 1 : SP_2019_RD1000_31_82_20190305_00034.jpg

This photo was taken from the crown facing downstream waterside levee slope at unacceptable landscaping.

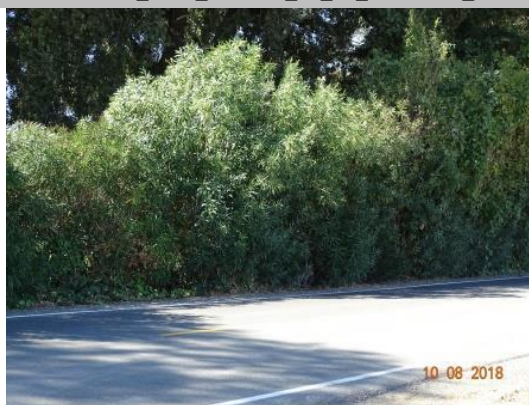
Photo 1 of 1 : SP_2019_RD1000_31_81_20190305_00033.jpg

View of landscape vegetation that blocks visibility and access.

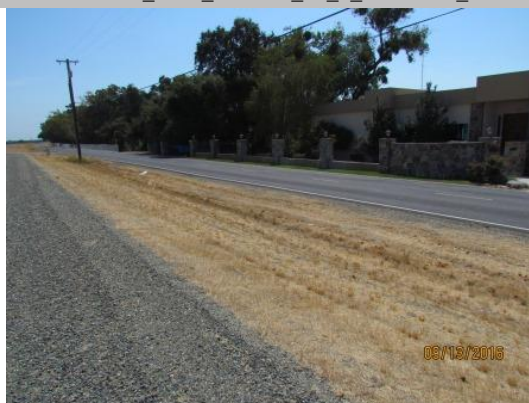
Photo 1 of 1 : SP_2019_RD1000_31_2_20190305_00001.jpg

This photo was taken during Fall 2015 from the crown facing downstream on the waterward levee slope at a fence enforcement issue. From the NOV all panels of the fence are to be removed. The owner has removed some of the panels between the post.

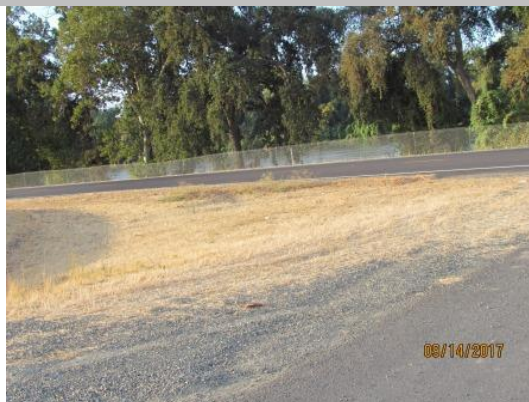
Photo 1 of 1 : SP_2019_RD1000_31_10_20190305_00008.jpg

View on waterside of a non-permitted fence.

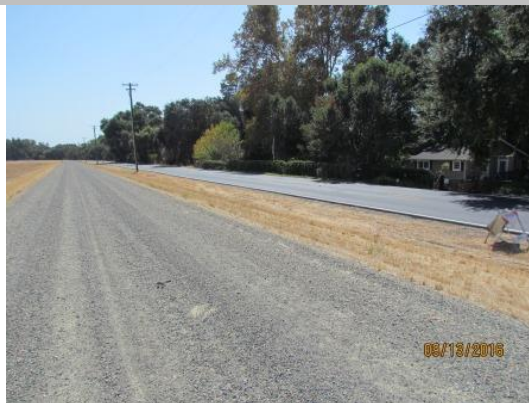
Photo 1 of 1 : SP_2019_RD1000_31_74_20190305_00031.jpg

This photo was taken from the crown facing downstream looking down the waterward levee slope at unacceptable landscaping.

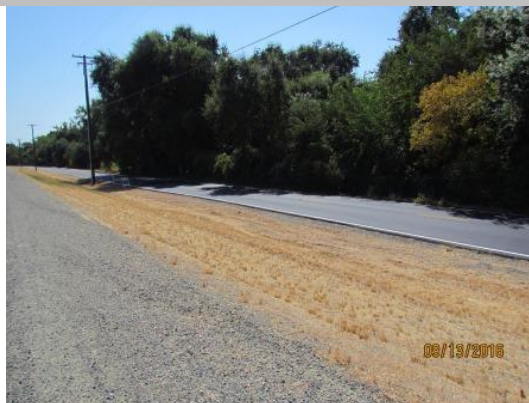
Photo 1 of 1 : SP_2019_RD1000_31_73_20190305_00030.jpg

This photo was taken from the crown facing downstream looking down the waterward levee slope at unacceptable landscaping.

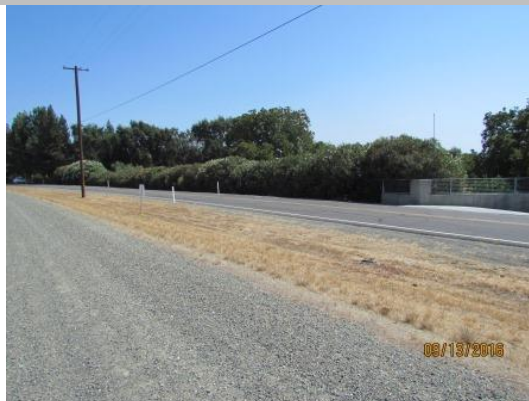
Photo 1 of 1 : SP_2019_RD1000_31_70_20190305_00029.jpg

This photo was taken from the crown facing downstream looking down the waterward levee slope at unacceptable landscaping.

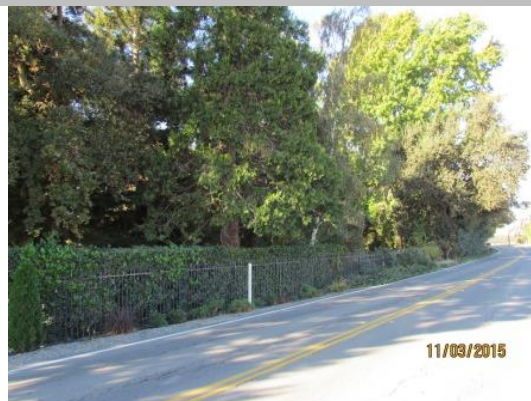
Photo 1 of 1 : SP_2019_RD1000_31_66_20190305_00026.jpg

View of the landscaping on the waterside levee slope.

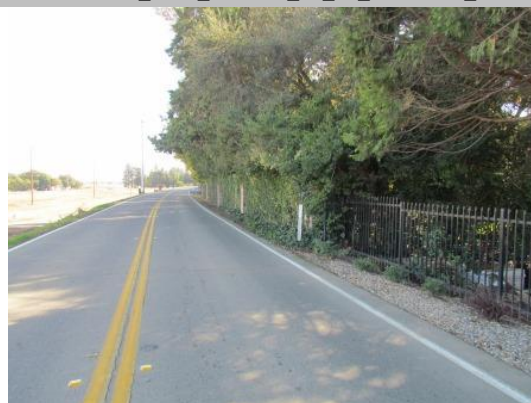
Photo 1 of 1 : SP_2019_RD1000_31_62_20190305_00025.jpg

This photo was taken from the crown facing downstream looking down the waterward levee slope at unacceptable landscaping.

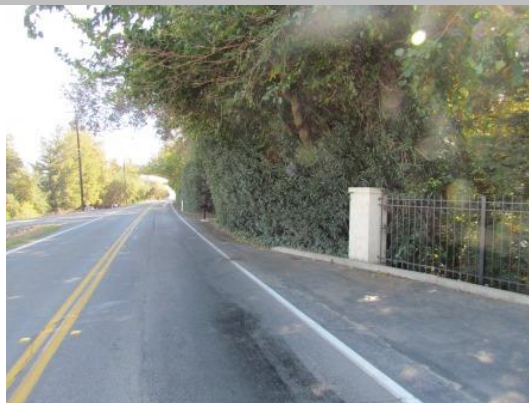
Photo 1 of 1 : SP_2019_RD1000_31_60_20190305_00024.jpg

This photo was taken from the crown facing downstream looking down the waterward levee slope at unacceptable landscaping.

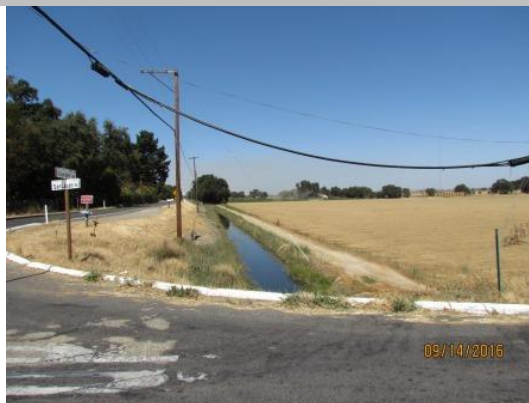
Photo 1 of 1 : SP_2019_RD1000_31_101_20190305_00039.jpg

View looking upstream at ditch on landside toe.

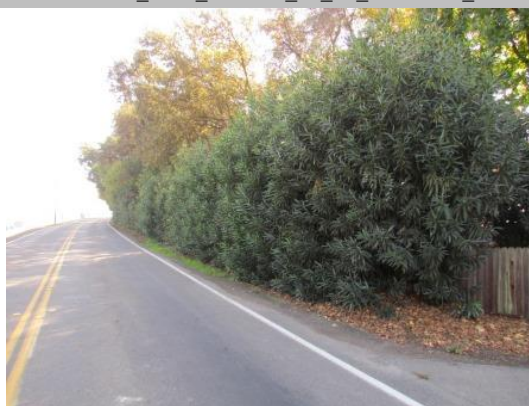
Photo 1 of 1 : SP_2019_RD1000_31_58_20190305_00023.jpg

This photo was taken from the crown facing downstream looking down the waterward levee slope at unacceptable landscaping.

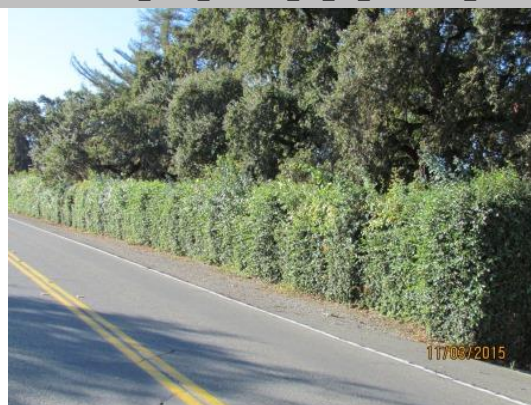
Photo 1 of 1 : SP_2019_RD1000_31_51_20190305_00021.jpg

View of the landscaping on the waterside levee slope.

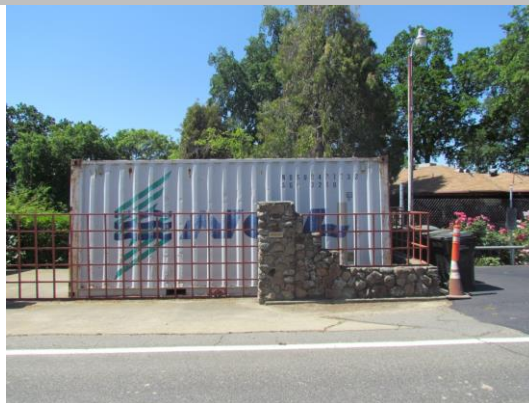
Photo 1 of 1 : SP_2019_RD1000_31_53_20190305_00022.jpg

View of storage container from the landside of the crown facing the waterside of the levee.

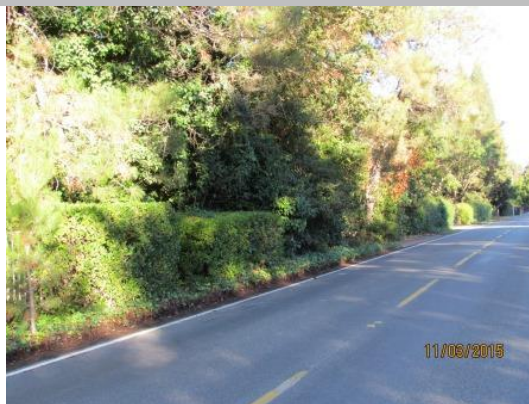
Photo 1 of 1 : SP_2019_RD1000_31_35_20190305_00016.jpg

View of the landscaping on the waterside levee slope.

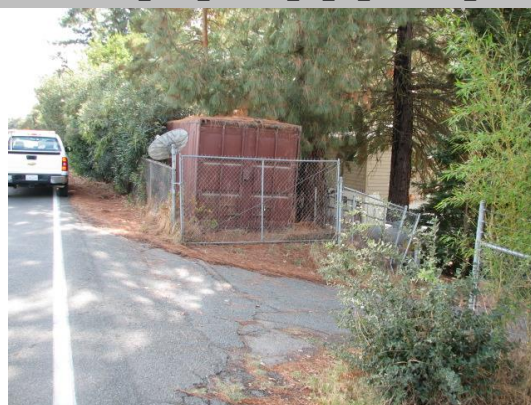
Photo 1 of 1 : SP_2019_RD1000_31_76_20190305_00032.jpg

Cargo container on levee shoulder, the property appears to be on fill material.

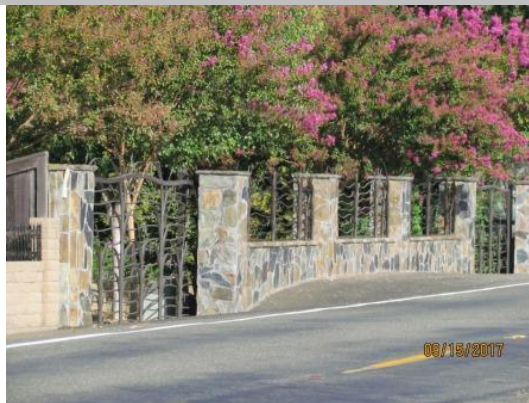
Photo 1 of 1 : SP_2019_RD1000_31_32_20190305_00015.jpg

View on waterside looking upstream of a rock and wrought iron fence that partially blocks visibility and access.

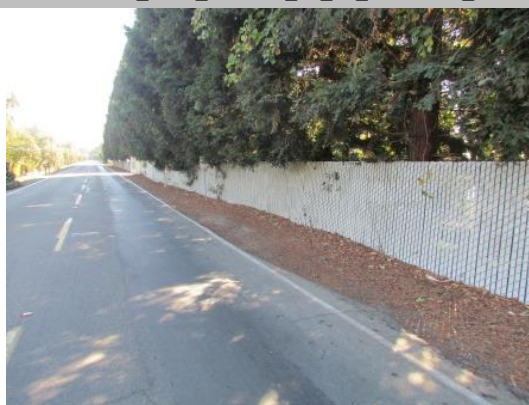
Photo 1 of 1 : SP_2019_RD1000_31_29_20190305_00012.jpg

This photo was taken from the crown facing downstream looking down the waterward levee slope at an unacceptable fence.

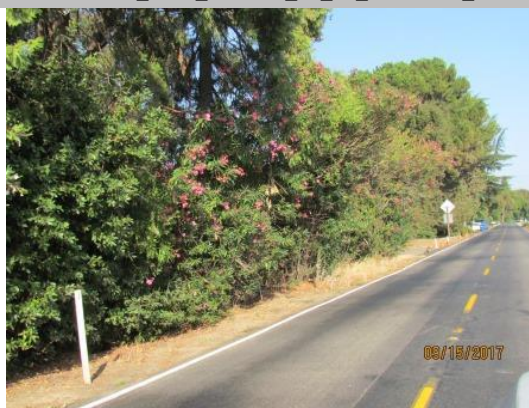
Photo 1 of 1 : SP_2019_RD1000_31_19_20190305_00011.jpg

View on waterside looking upstream of property covered by Oleander Bushes.

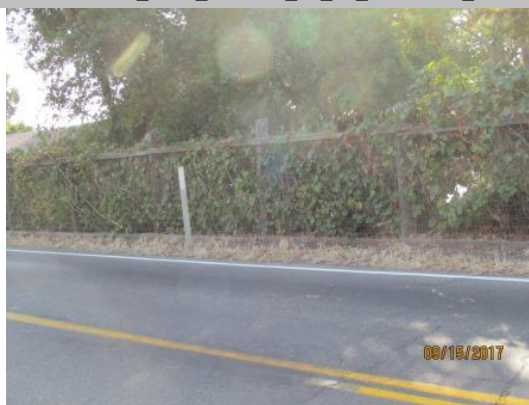
Photo 1 of 1 : SP_2019_RD1000_31_14_20190305_00010.jpg

View on waterside looking across at the fence covered by vegetation.

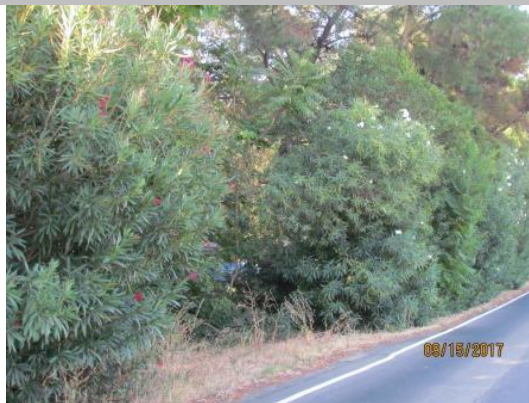
Photo 1 of 1 : SP_2019_RD1000_31_13_20190305_00009.jpg

View of fence covered by Oleander Bushes.

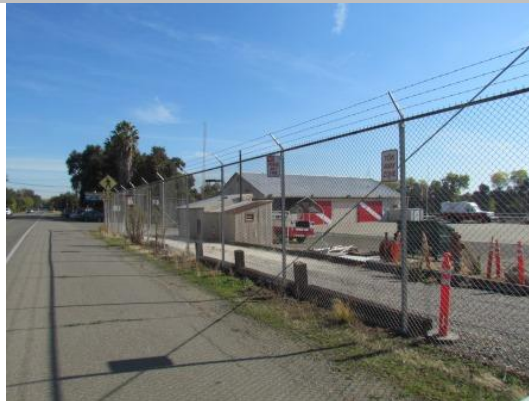
Photo 1 of 1 : SP_2019_RD1000_31_8_20190305_00006.jpg

This photo was taken from the crown facing downstream looking down the waterward levee slope at an unacceptable building.

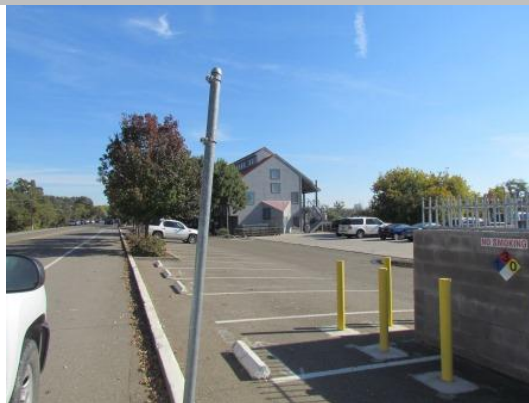
Photo 1 of 1 : SP_2019_RD1000_31_5_20190305_00005.jpg

This photo was taken from the crown facing downstream looking down the waterward levee slope at an unacceptable building.

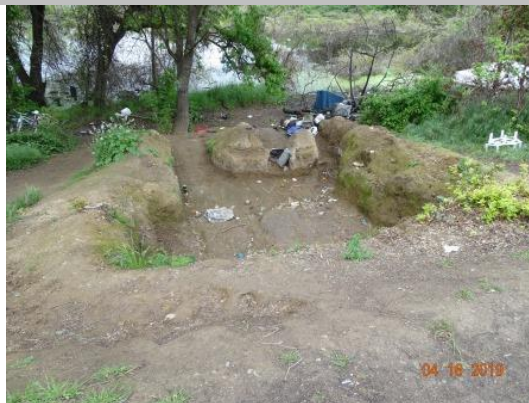
Photo 1 of 2 : SP_2019_RD1000_32_3_20190418_00001.jpg

View looking down the waterside slope where the homeless have dug into the levee slope, Spring 2019.

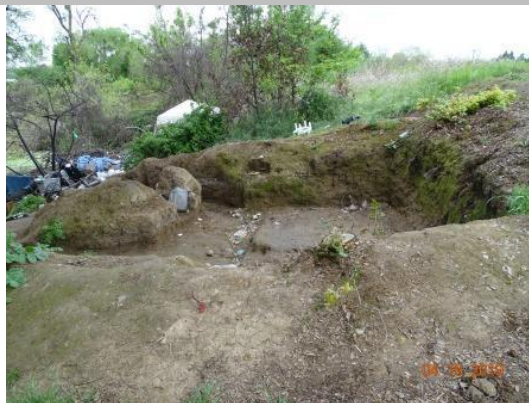
Photo 2 of 2 : SP_2019_RD1000_32_3_20190418_00002.jpg

View looking upstream waterside slope where the homeless have dug into the levee slope, Spring 2019.

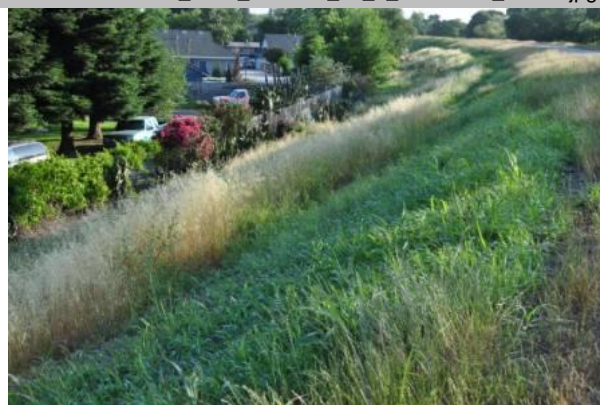
Photo 1 of 2 : SP_2019_RD1000_33_7_20190305_00005.jpg

Fence with vegetation at LS toe.

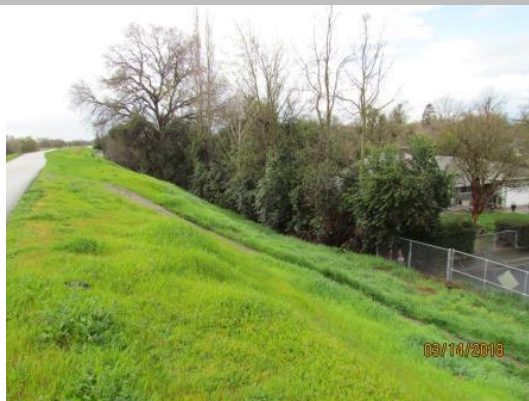
Photo 1 of 1 : SP_2019_RD1000_33_4_20190305_00004.jpg

View looking downstream landside of fence at levee toe, Spring 2018.

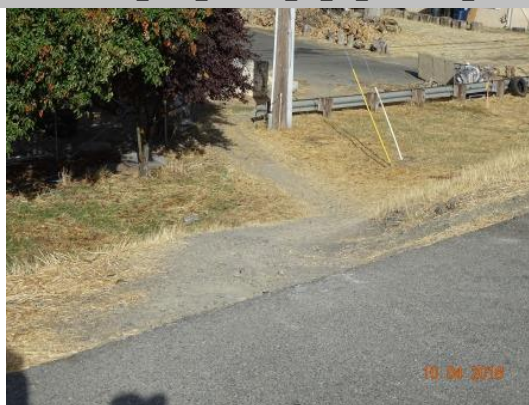
Photo 1 of 1 : SP_2019_RD1000_33_14_20190305_00011.jpg

View looking down the landside levee slope at a rut created by foot traffic, Fall 2018.

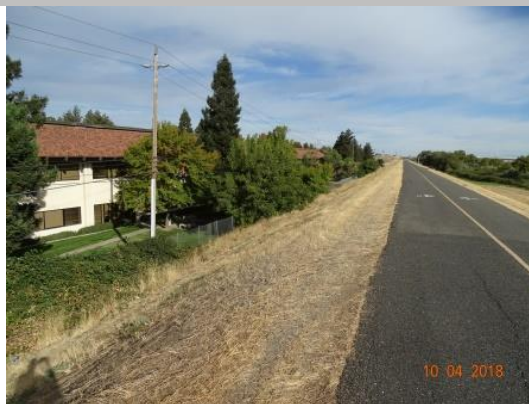
Photo 1 of 1 : SP_2019_RD1000_33_17_20190305_00013.jpg

View looking upstream landside of fence at levee toe, Fall 2018.

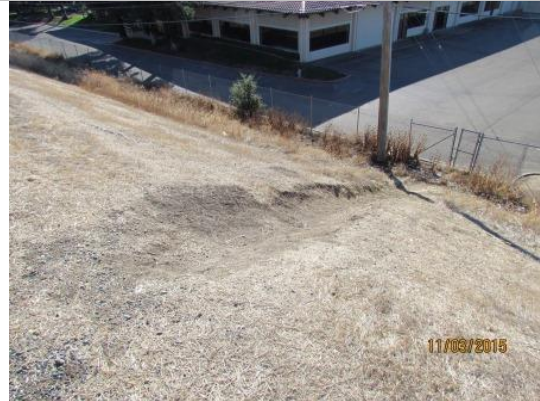
Photo 1 of 1 : SP_2019_RD1000_33_15_20190305_00012.jpg

View of the landside levee slope damaged by foot traffic.

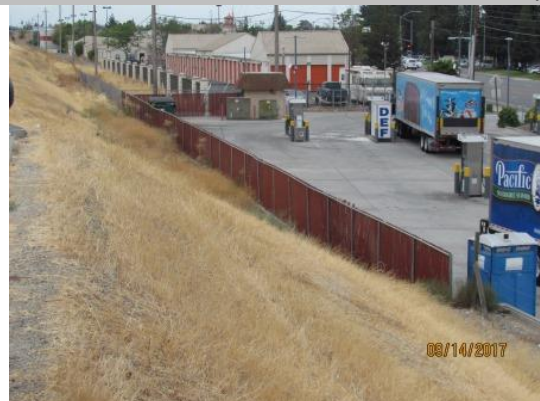
Photo 1 of 1 : SP_2019_RD1000_33_3_20190305_00003.jpg

View looking downstream landside of fence that encroaches at levee toe, Fall 2017.

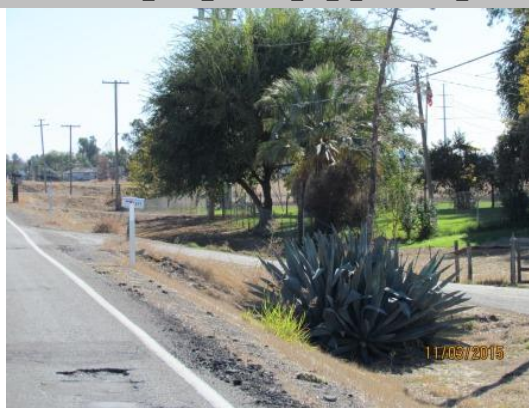
Photo 1 of 1 : SP_2019_RD1000_33_2_20190305_00002.jpg

View of the landscaping at the landside levee toe.

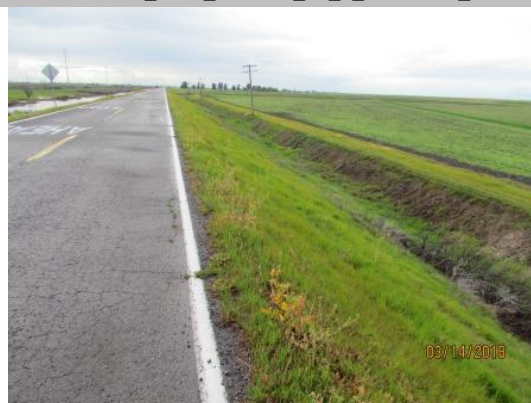
Photo 1 of 1 : SP_2019_RD1000_33_9_20190305_00008.jpg

View looking downstream landside at a ditch at the toe, Spring 2018.

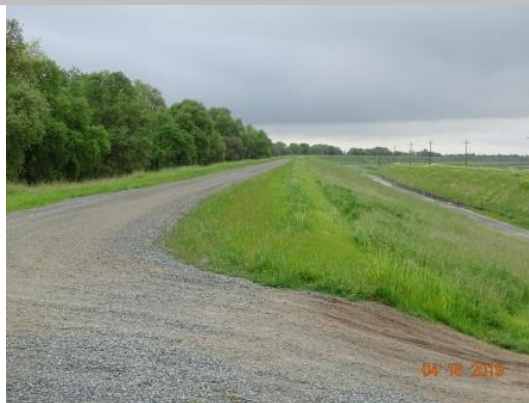
Photo 1 of 1 : SP_2019_RD1000_34_13_20190418_00001.jpg

View looking upstream landside at the annual vegetation, Spring 2019.
